# **Environmental Management Plan (Maintenance)**

Clump Point Boat Ramp Access Silt  
Clearing

Mission Beach Clump Point, Boating  
Infrastructure Project, Element 1: CN-10244

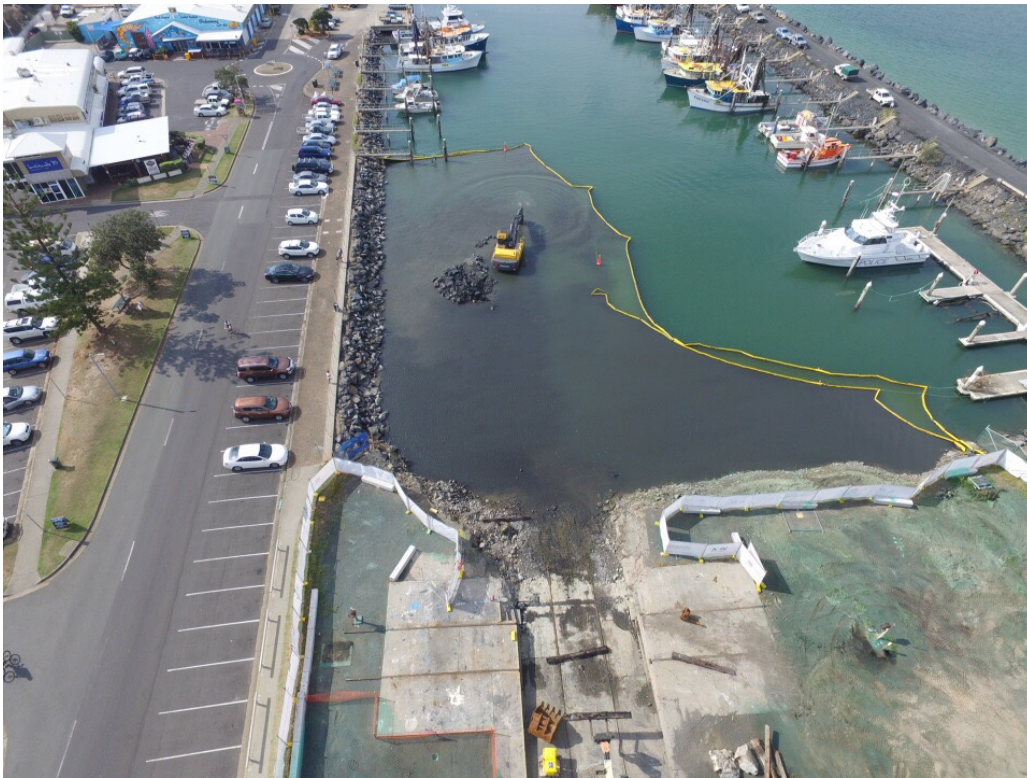
MGN successfully adopted this technique within the Coffs Harbour Marina. Refer image below for an aerial shot of the Coffs Harbour project. TMR also adopted a similar approach when silt was cleared from the Clump Point Basin previously.

The planned maintenance works include the use of a 50T excavator and 35T Dump Truck with a series of temporary access fingers into the boat ramp basin to remove the silt. It is proposed that the access finger(s) will be constructed from clean Class VIII core rock. The access fingers will only be placed within the dredge basin footprint being disturbed and will be completely removed at the completion of works. Pre and post dredge surveys will be undertaken to confirm the volume of material removed for contract payment purposes (and to meet permit conditions 11-13 in G18/38869.1). These surveys will confirm that all access finger material is removed from the basin area at completion of works.
